Surface Examination Report
 Mineral Mountain, Negro Mag Wash Area
 State Volcanic Material Leases ML-3092
 Beaver County, Utah

Date of Inspection: June 19, 1995
 Conducted by: William M. Stokes, SITLA, Minerals
 Conditions: Excellent
 Lands: SE $\frac{1}{4}$ Section 2, T. 27 S., R. 9 W. SLM

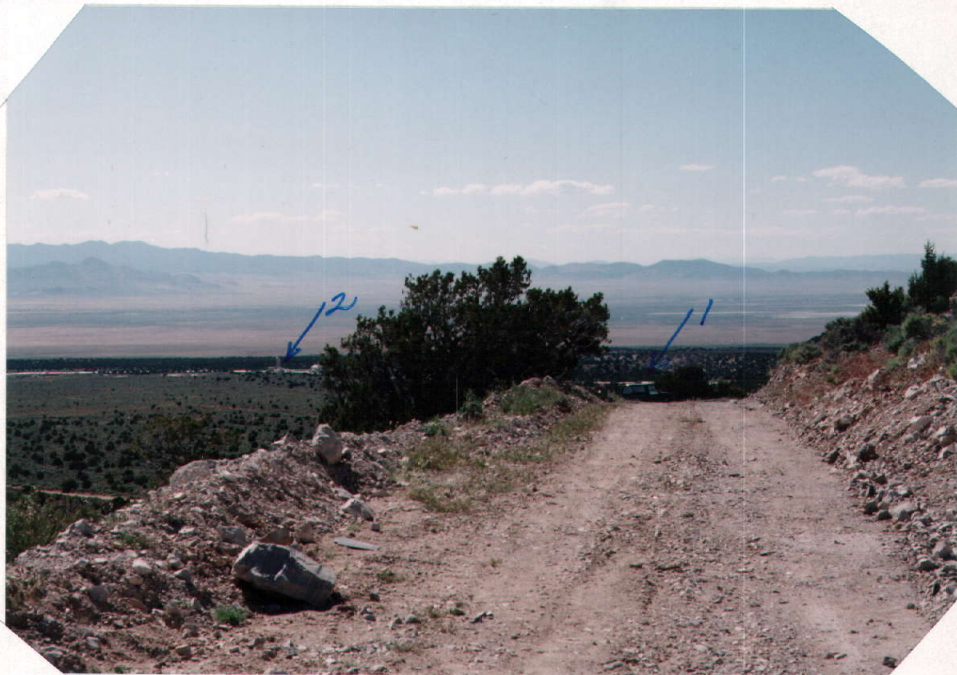
Photo. # 1, Looking west from the main mine area at site "A". This road has been widened to access the mine at site "A". Arrow # 1 shows location of the turnout which has also been enlarged by mining activity. Arrow # 2 show the location of the Bundell geothermal power plant.

Site "A", which is the southern most mined area, appears to be the location of the most recent mining activity. This activity may have occurred late in the Fall of 1994 or early in the Spring of 1995. It appears that portions of the main road and a turnout of the main road leading to site "A" have been widened. The access road is approximately 909 feet long and 15 feet wide. The road turnout disturbance is approximately 100 feet wide and 100 feet long. Both the access road and the turnout create a disturbance of approximately 23,635 sq. ft. or approximately .54 acres. (See Photo # 1) The mining at site "A" had disturbed an area which is approximately 50 feet wide and 120 feet deep, equal to about 6,000 sq. ft. or approximately .14 acres. (See Photo # 2) Of some concern is a 25 foot high wall that has been cut into the fractured rock at site "A". This high wall could pose a safety hazard. Total mine related disturbances at site "A" covers approximately .68 acres.

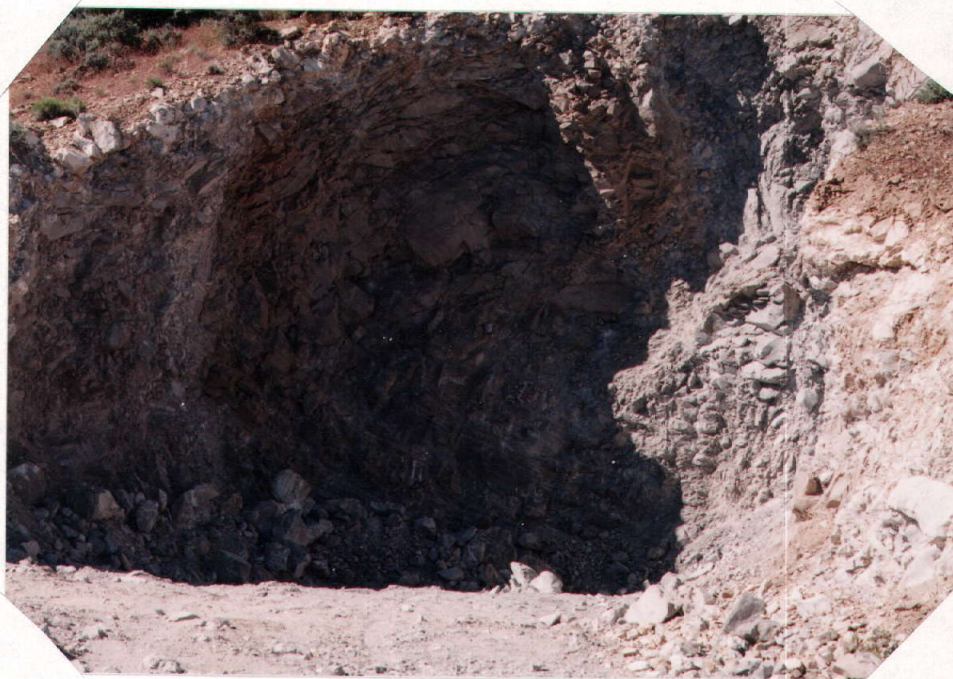
Photo # 2, Looking north onto the main mine area at site "A". Note the condition of the 25 foot high wall at the back of the excavated area. This high wall is slightly undercut in places and may pose a safety hazard.

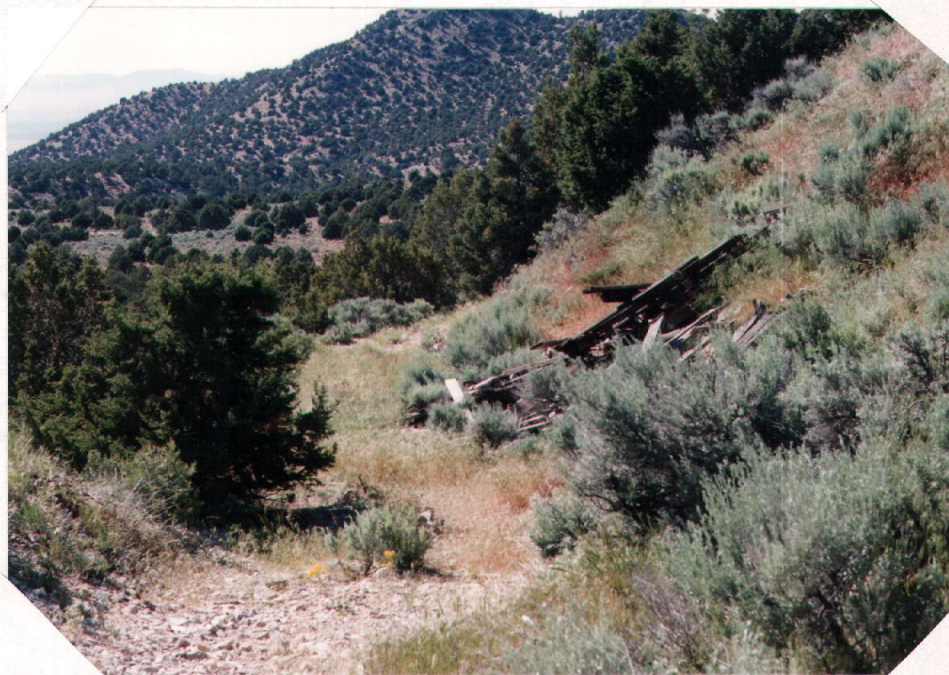
Photo # 3, Looking northwest along the main access road to mine site "B" on ML-3092. Note that the road is overgrown with sage and grass and appears not have been used for a considerable time.

The mine disturbance at site "B" appears to be quite old and may not be the responsibility of the current Lessee. Site "B" shows no evidence of recent mine activity as both the mine area and the access road are overgrown with grass and sagebrush. (See Photos 3 & 4) The old access road is approximately 650 feel long and approximately 10 feet wide or approximately .15 acres of

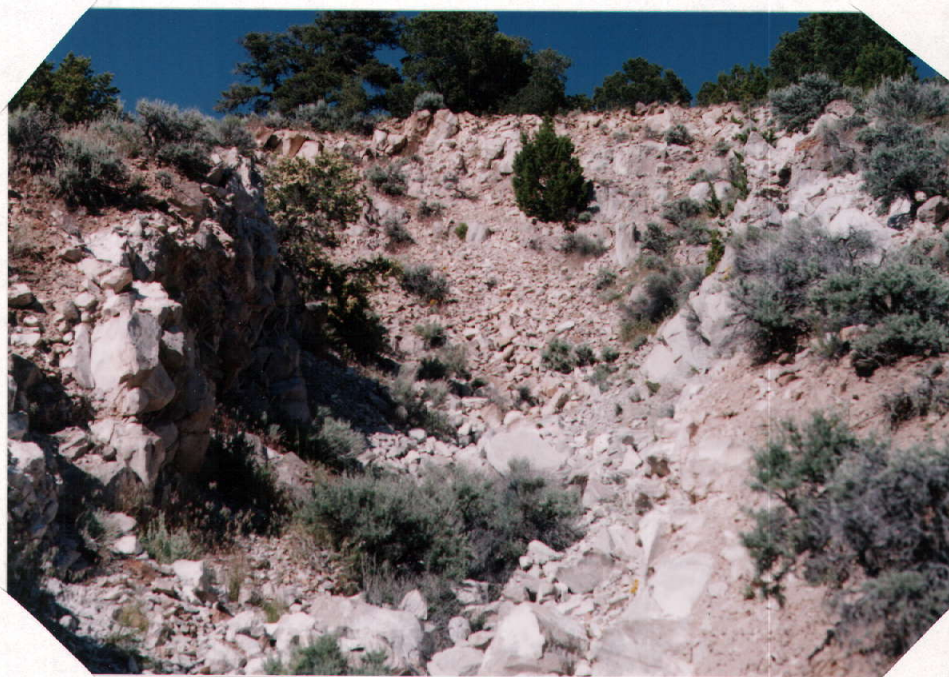
Photo # 4, Looking north onto the mine disturbance at site "B". Note the old mine site has been overgrown with sage and juniper.

disturbance. The old mine area at site "B" is approximately 60 feet long and approximately 20 wide or approximately .02 acres. Old mine related disturbances at site "B" total approximately .17 acres.
